STS-106 FLIGHT READINESS REVIEW

August 29, 2000

Orbiter

AGENDA

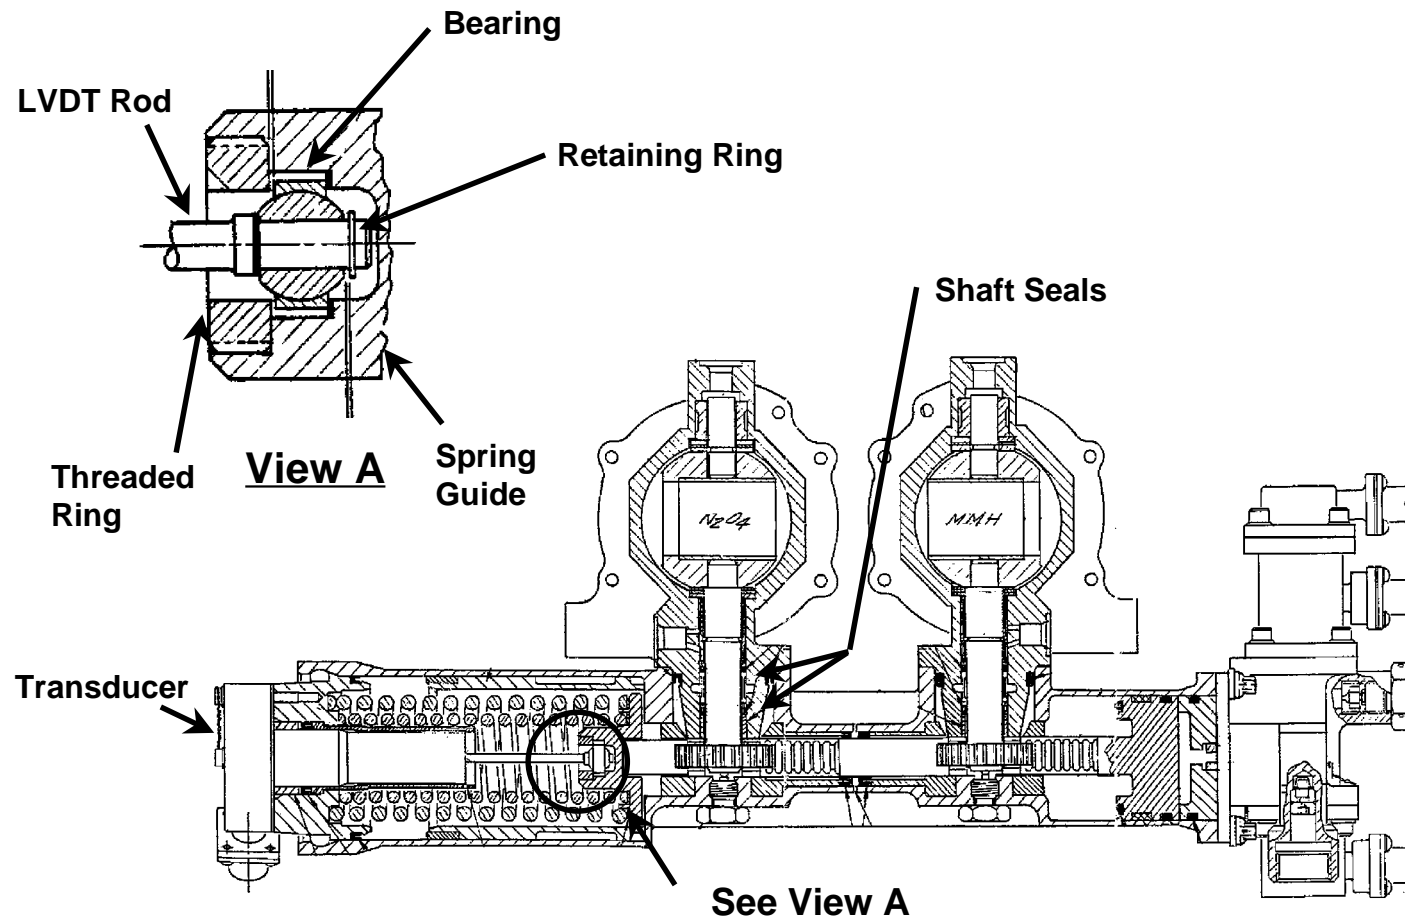
Bipropellant Valve with LVDT Rod End Detail

**STS-101-V-01: LOME Bipropellant Valve Indication
Failed Open**

- Following the STS-101 OMS-3 burn, the left OMS engine (S/N 111) bipropellant valve (BPV) #2 position indicated failed open
- Post-flight troubleshooting isolated the problem to the linear variable differential transducer (LVDT) which provides the valve position indication
- Confirmed the failure was instrumentation only
- LVDT #2 was R&R'd and failed LVDT was returned to WSTF for TT&E
 - TT&E determined LVDT rod was stuck in transducer and retaining "C" clip had come off end of rod in spring guide
 - Formation of contamination on LVDT rod, formed as a result of oxidizer permeation beyond valve shaft seals, restricts movement of rod enough to overcome the capability of the retaining clip

- Determined corrective action for LVDTs remaining in the fleet which have the highest potential for contamination
 - OV-102 LOME LVDTs will be replaced prior to flight (STS-107)
 - OV-103 LOME LVDT #2 will be replaced during next flow (STS-102)
 - OV-104 LOME LVDT #1 will be replaced next flow (STS-98)
 - All remaining LVDTs are acceptable
- Acceptable for STS-106 Flight
 - New LVDT, spring guide, and springs installed in bipropellant valve #2 – OMRS retest within spec
 - Failure is visible and manageable in flight
 - Flight rules allow use of engine with failed open indication for deorbit burn
 - Subsystem redundancy exists - two OMS engines and four +X RCS thrusters

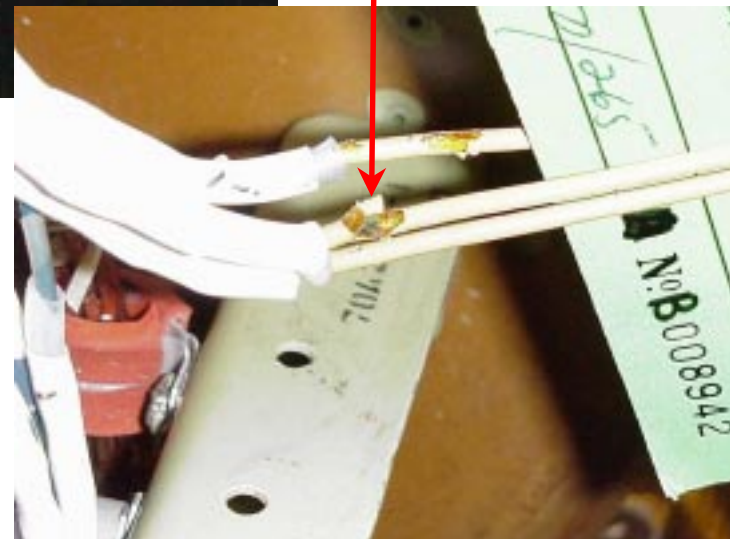
CONDUCTOR DAMAGE

- Forward
 - 56% (290/521) of PR conditions and 70% of exposed/damaged conductors found in flight deck
 - 24 exposed conductors
 - 27 damaged conductors
 - ***None found in shorting proximity of other conductors or structures***
 - No new modes of damaged observed
 - No unique groupings found that would indicate a common cause for mechanically-induced damage
- Mid
 - No new modes of damaged observed
 - No unique groupings found that would indicate a common cause for mechanically-induced damage

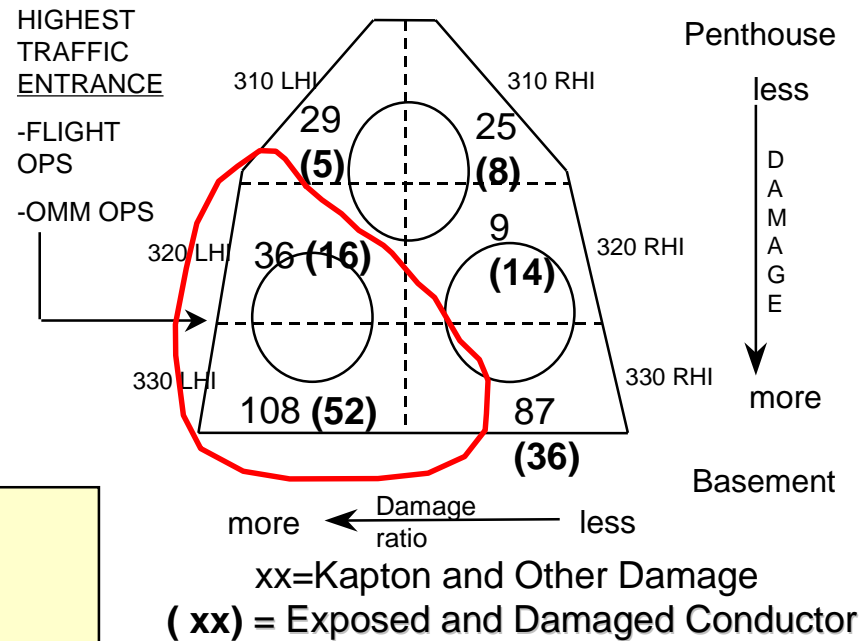
AFT VIEW OF SHUTTLE ZONES

Vehicle	Kap/Oth	Exp/Dam
102	364	151
103	227	60
104	398	55
105	89	27

Key trends noticed:

- Higher damage seen in high traffic areas
- Exposed/damage conductor in monoball connectors
- Risk of short with exposed conductor found near connector backshells

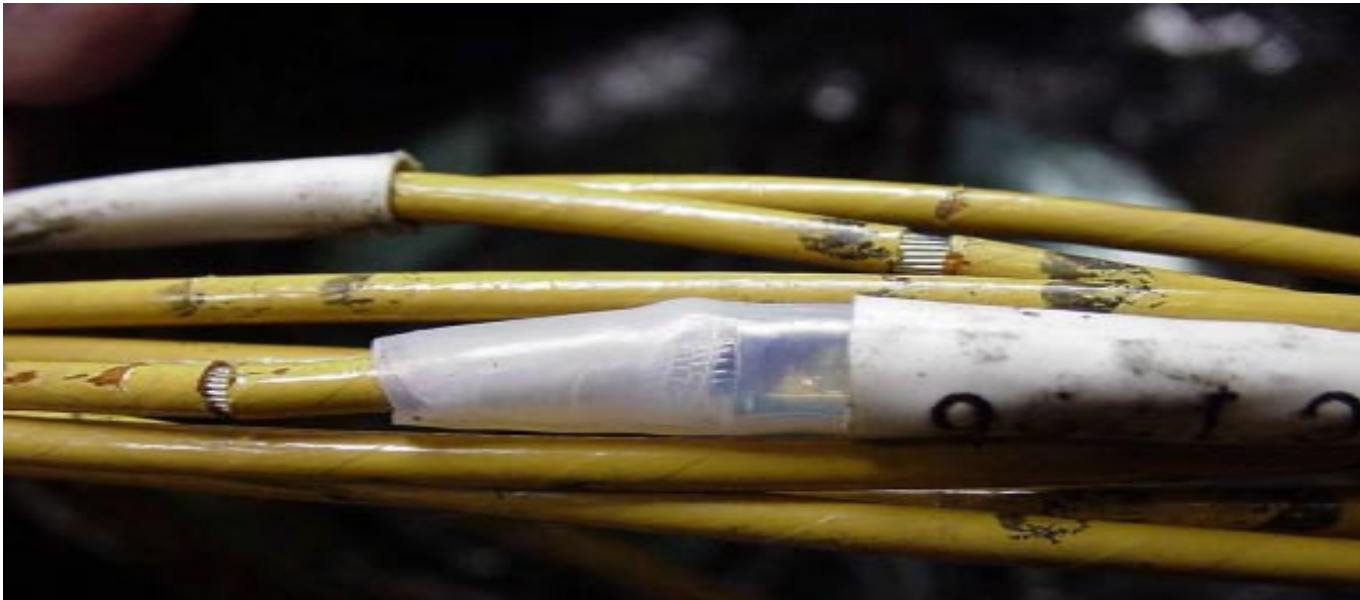
- Cursory inspection on 12 gage SRB-ORB-BUS wires located within ET monoball metal connectors. Radial cracks were found four inches from the main connector mate area within the 8-inch connector assembly
- ***Similar monoball area damage found and repaired in rest of fleet***

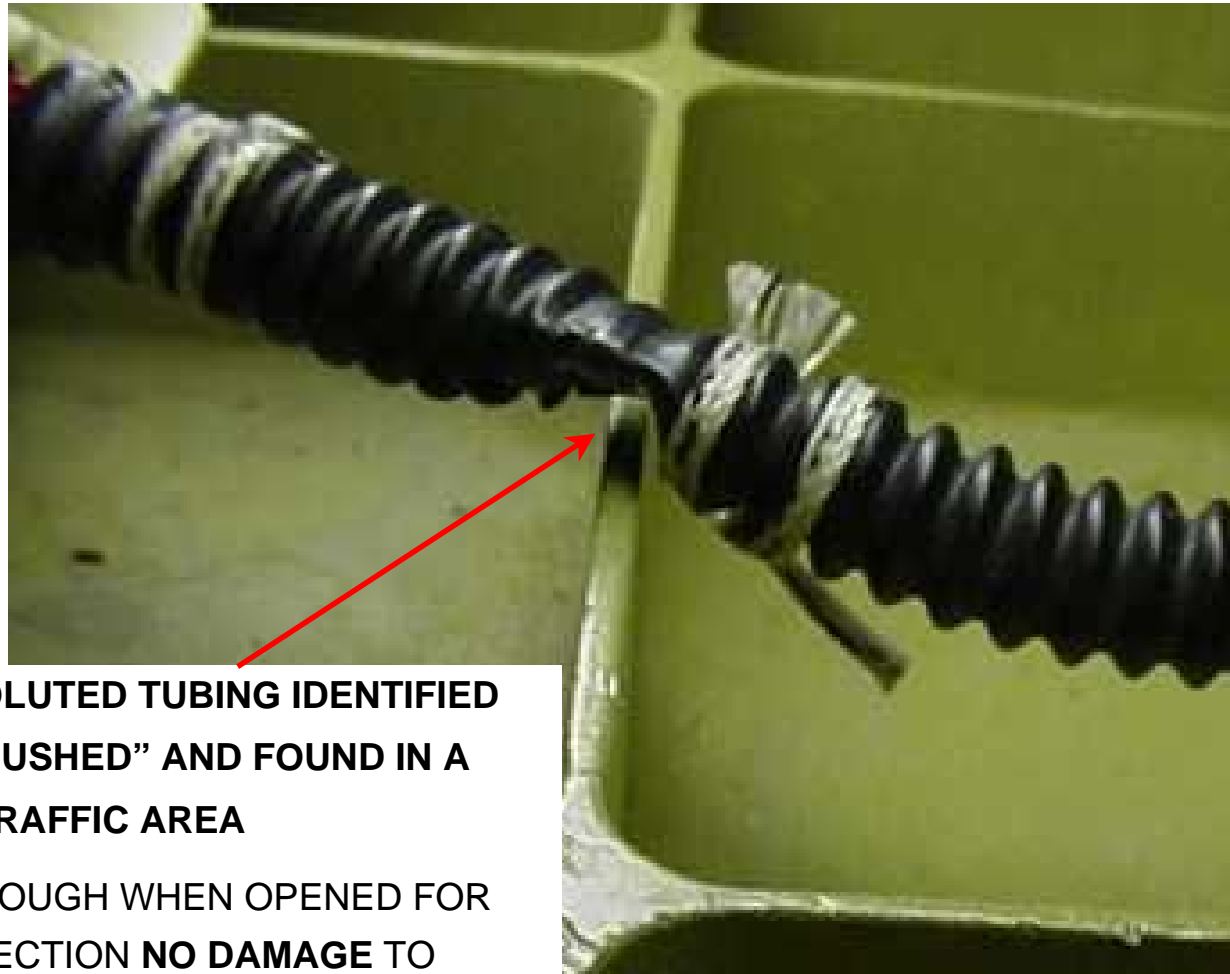
**CONVOLUTED TUBING IDENTIFIED
AS “CRUSHED” AND FOUND IN A
HIGH TRAFFIC AREA**

- ALTHOUGH WHEN OPENED FOR INSPECTION **NO DAMAGE** TO WIRING WAS DISCOVERED

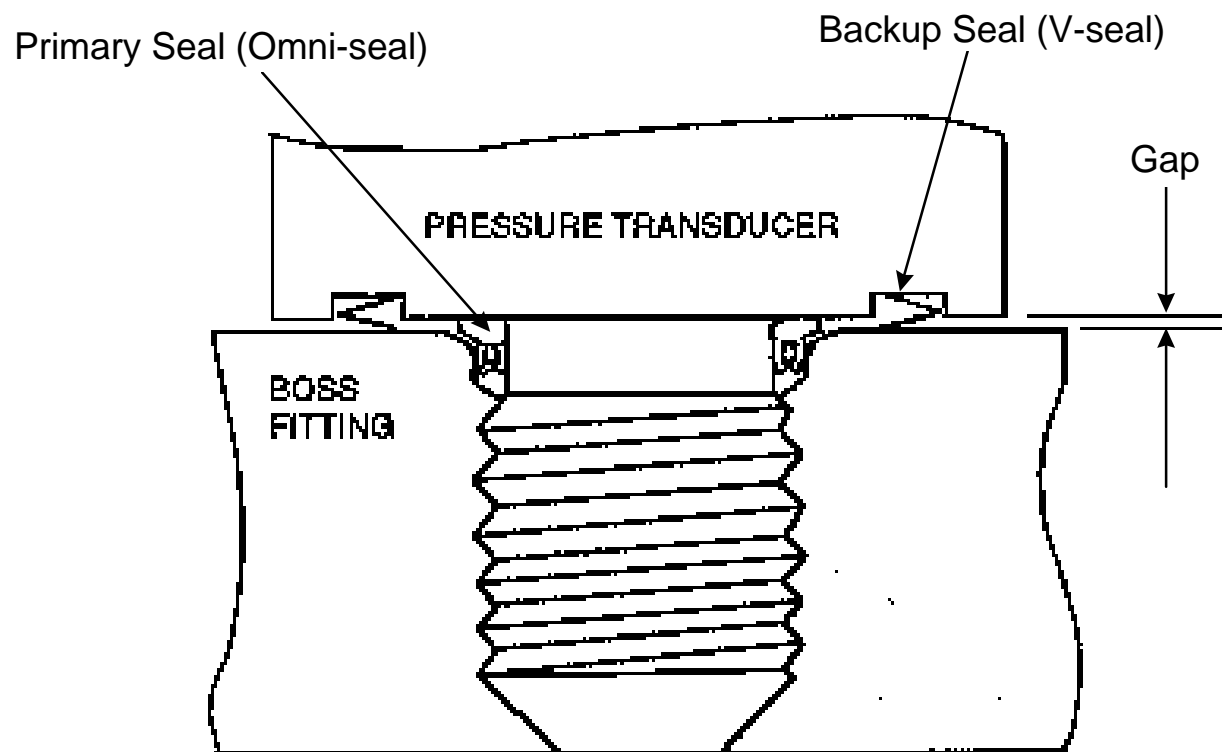
Transducer/Boss Configuration

- OMS engine transducer bosses have primary and backup seals to protect against leakage
 - Omni-seal and V-seal
- Drawings specify torque and gap requirements to ensure both seals are engaged
- Leak check performed to verify seal
 - Unable to confirm both seals are engaged by leak check

- Performed transducer/boss gap measurements on OV-104 OMEs to ensure seal engagement exists
 - All gaps on LH OME are per print
 - P_C , fuel, and oxidizer pressure transducer gaps on RH OME are per print
 - Temperature transducer gap is 0.005" and will be MR accepted as-is
 - Two GN_2 pressure transducer gaps, PT5 and PT6, measured 0.006" and 0.007", respectively
 - Will be removed and replaced before flight

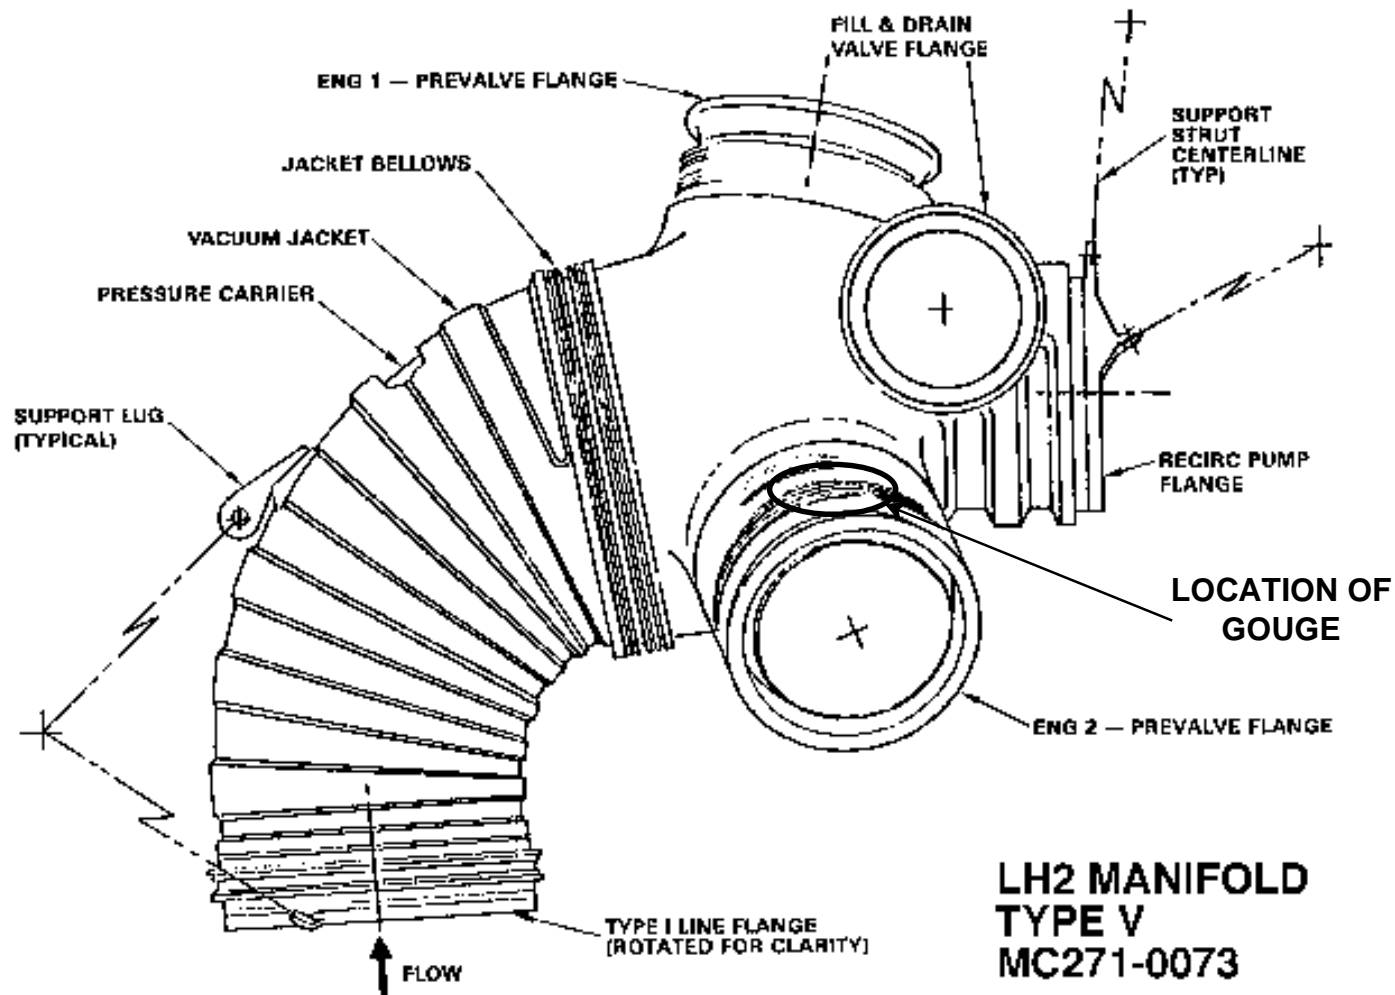
- Dye penetrant inspection of gouge located on the OV-104 LH2 feed manifold bellows revealed through-damage of the outer bellows ply prior to STS-101
- X-rays taken during STS-106 flow indicate that the damage may also exist in the inner ply

Looking Outward to vehicle port side
Top of tank with vehicle on horizontal position

Crack with possible fatigue propagation indication

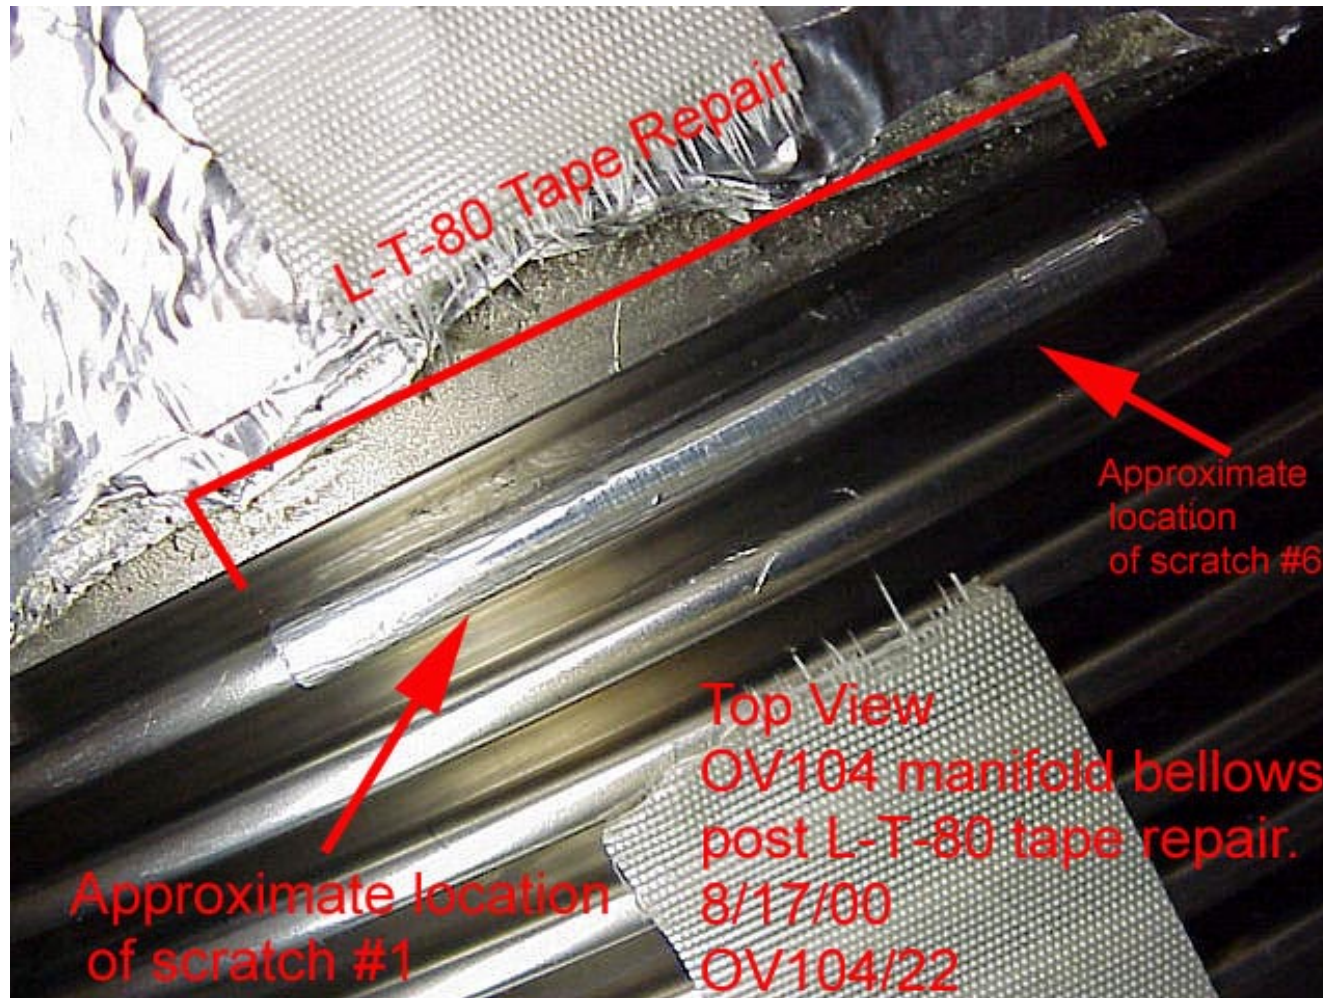
- All test articles passed all mass spec leak checks with essentially zero leakage (less than 1×10^{-8})
- All test objectives satisfied
- Laboratory tests verified future X-rays will not be obscured by tape repair
- If inner ply defect X-ray is questionable, tape can be removed to verify vacuum integrity and then reapplied

- One-flight MR repair developed
 - Utilizes L-T-80 tape to provide vacuum barrier
- Development test article
 - Single incision damage with L-T-80 tape repair
 - Extended evacuation pump down
 - Mass Spec Leak Test
 - Monitor and record vacuum decay
 - Low temperature thermal cycling (ambient to -30 F)
 - Loading environment compression cycles
- Verification test article
 - Same as development except 3 incisions on test article

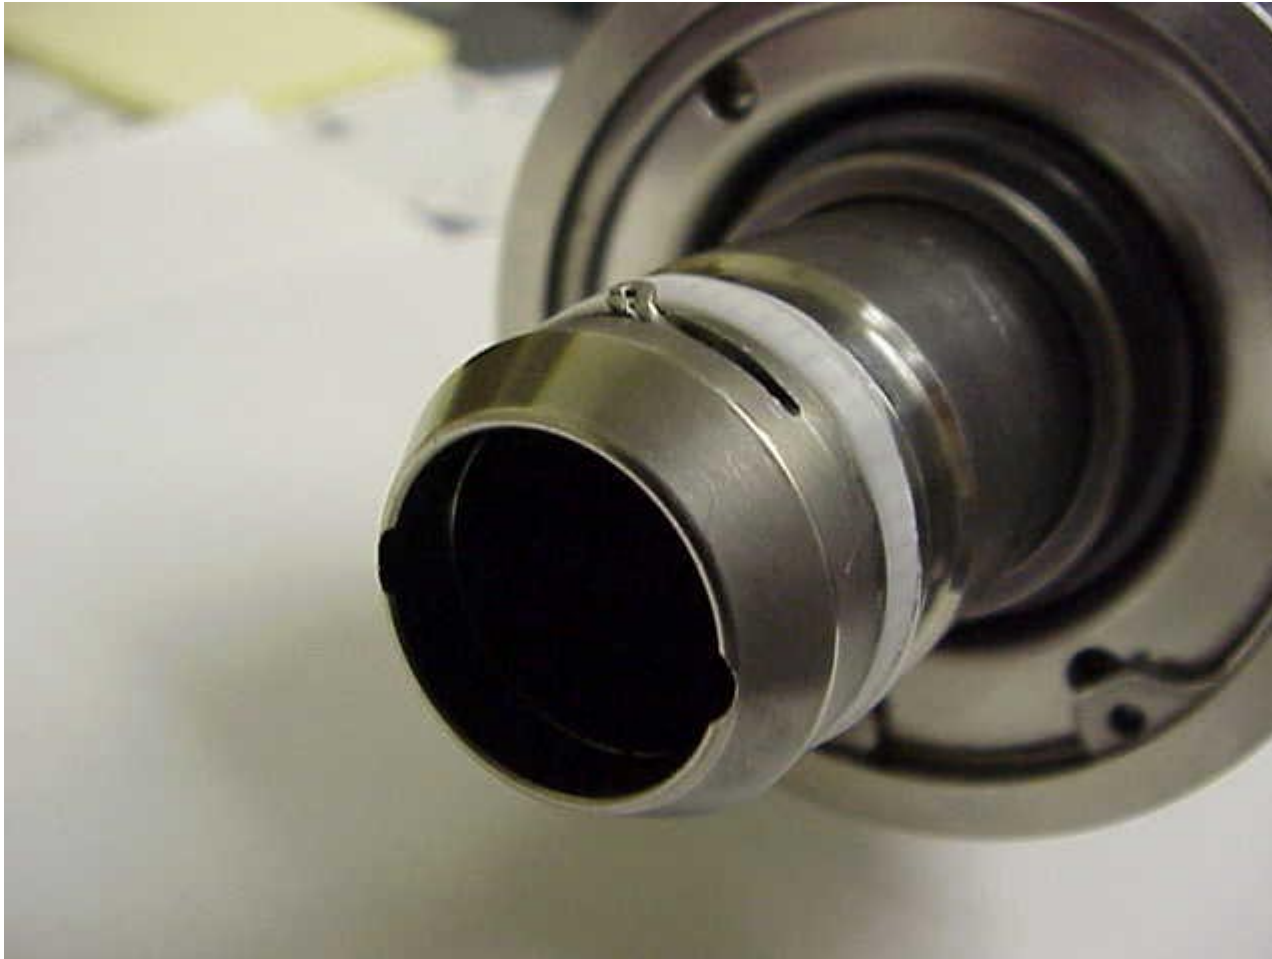
PD9 Ground Half

- Troubleshooting of the observed leakage involved isolating individual systems
 - After ground side of GO2 pressurization line was vented, leakage immediately decreased to zero
 - Indicated leakage source located upstream of CV16
- Point-to-point leak checks of the line upstream of CV16 revealed a significant leak at Prepress Disconnect, PD9
 - Ground half of PD9 was removed and two anomalies were observed
 - Pressure assisted interface seal installed backwards
 - Locking pin used to hold seal retainer was not properly retracted into retainer
 - Inspections of Orbiter half showed that two gouges had been created by interference with locking pin

- Ground half disconnect has been replaced
 - Correct installation of interface seal eliminates loss of anti-icing purge failure scenario
- Helium signature test of GO2 pressurization system has been successfully reperformed
 - Verifies Orbiter GO2 plumbing ready to fly
- Isolating leakage to interface side of PD9 eliminates criticality 1 failure scenarios during SSME run
- No risk of particle impact ignition

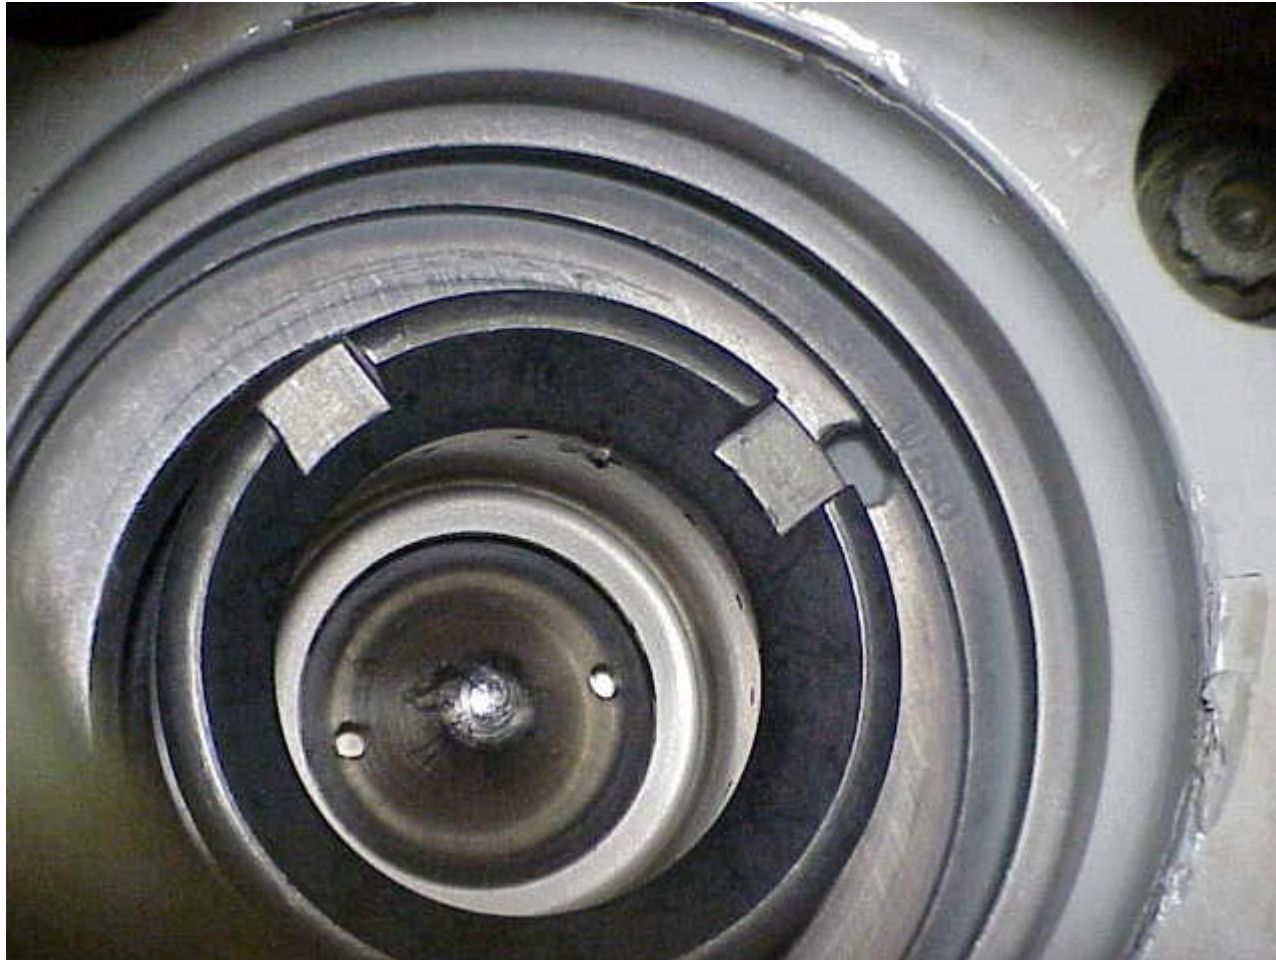
PD9 Flight Half

- Ground half disconnect replaced
- Mold impressions of flight half disconnect showed damage confined to an area 0.303" x 0.112"
 - Maximum depth measured was 0.0026"
 - Minor amount of raised metal at the inboard end
- Disconnect halves remated
 - Successfully passed leak check
 - Helium signature rest for GO2 system reperformed
- Due to nature of damage to Orbiter half, potential for metallic contaminant in GO2 system does exist
 - Based on worst-case dimensions from mold impression, up to 6 mg could be present
 - Previous analyses and testing for particle impact ignition envelope this small amount of contaminant

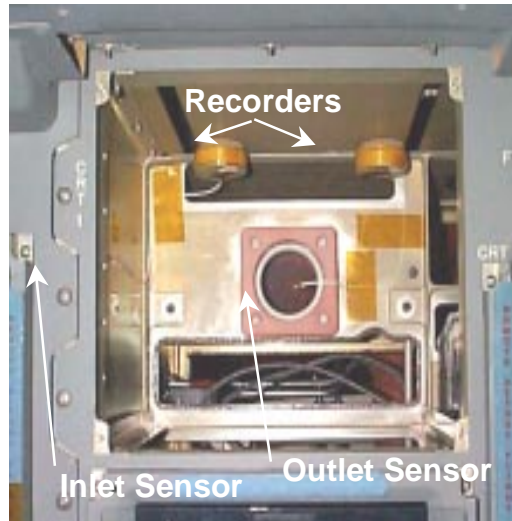
Micro-WIS Recorders Installed at
DPS 1 Location

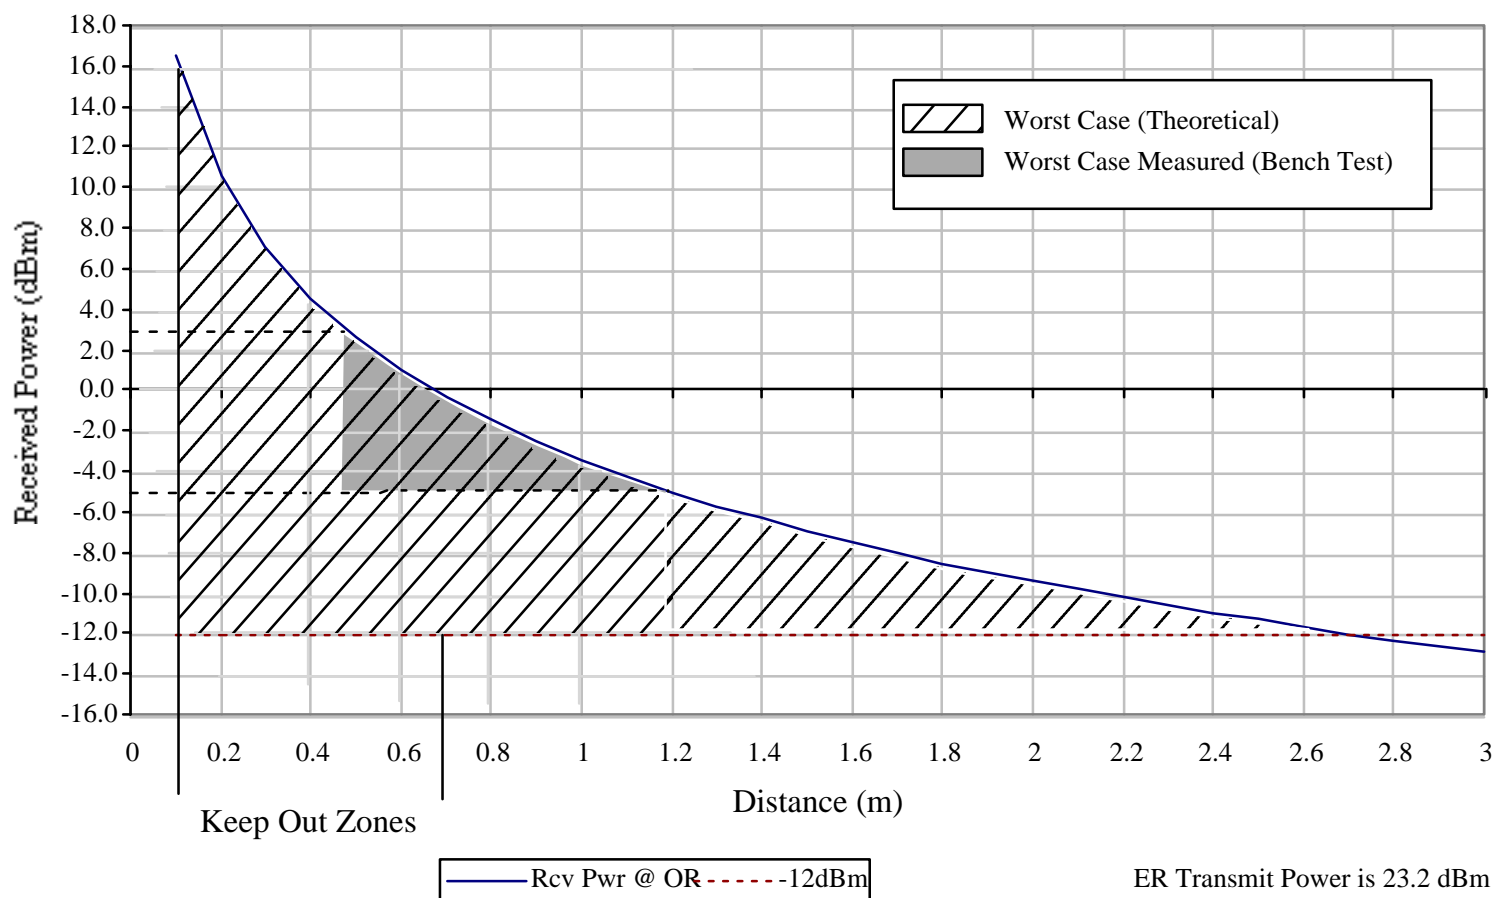
GFE BU-2

Strong Signal Anomaly: Area of Potential Loss of Comm.
Distance Between EMU and SSOR Antenna vs. Power Received by SSOR

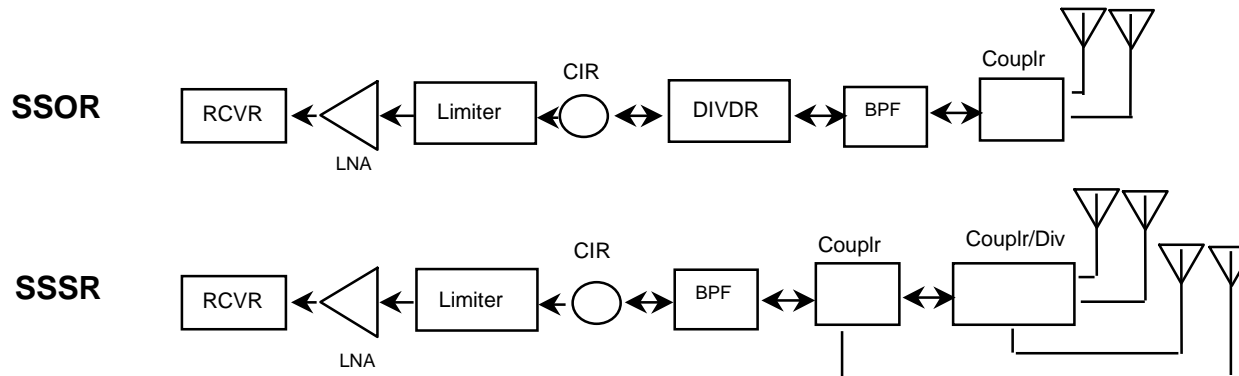
Strong Signal Discrepancy

SSER design is different from SSOR/SSSR
